**BOG BROOK DAM NO. 1  
AND DAM NO. 2**

**PHASE I INSPECTION REPORT**

**NATIONAL DAM SAFETY PROGRAM**

**DAM NO. 1 - NY 00068  
DAM NO. 2 - NY 00069**

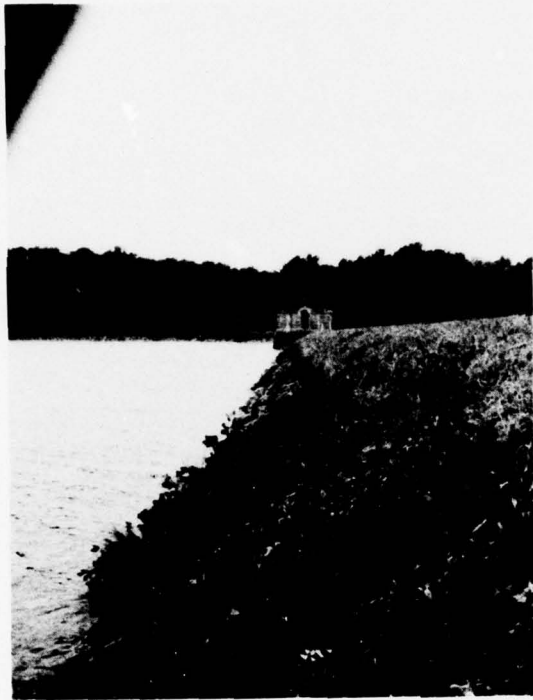
UPSTREAM SLOPE AND  
CENTER GATEHOUSE DAM NO. 1

The dam crest, as well as the uppermost four feet of the upstream slope, is grass covered. Two long, shallow depressions were noted in the embankment crest: one immediately in front of the center gatehouse and another approximately 150 feet to the north. Each depression grades parallel to the long axis of the dam and reaches a maximum depth of about 18 inches. According to the operating personnel, these features have been noticeable for a period of years.

A boring program should be initiated at several sections (including the depressed areas) of the embankment to include, but not be limited to, determination of the composition and in-situ properties of the embankment and foundation materials to establish if they are satisfactory for the embankment, corewall and foundation as designed and constructed; to assist in the determination of the cause of the seepage and to detect possible fines migration. The results of these investigations should be used to perform seepage and stability analyses for the embankment.

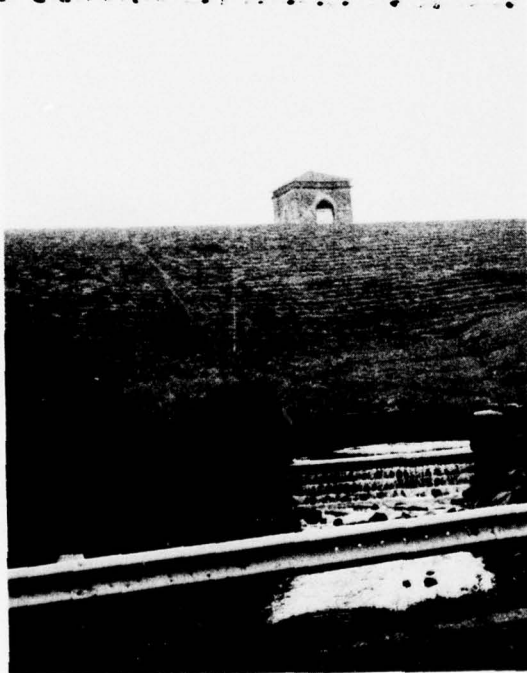
DOWNSTREAM SLOPE AND  
STILLING BASIN DAM NO. 1

The entire downstream face of Dam No. 1 is covered with grass which is reported to be mowed about twice a year. No indications of settlement or slope misalignment were noted on the slope during the inspection. The toe drain extending from the southeast abutment to the center of the embankment is partially obscured by grass and brush growing amongst the cobble backfill. Some ponded water was noted in the drain during the inspection. Seepage was observed where the downstream slope of the embankment intersects the north slope of the stream valley. The ground surface, for about 20 yards to either side of the intersection and extending from the valley crest to the toe of the embankment is generally very moist and saturated in a few locations. Wheel ruts about 12 to 15 inches deep have been cut into the embankment and valley slopes in this area by the mowing equipment.

e. Stilling Basin and Downstream Channel - Extensive underwater plant growth was observed in the stilling pond and vines were seen growing between the rocks which form the walls of the basin. The cross-section of the stone lined channel downstream of the stilling basin appears uniform but is overgrown with weeds and brush. Flow from the stilling basin is conveyed through a 7 foot diameter culvert under a road located about 100 yards downstream of the dam.

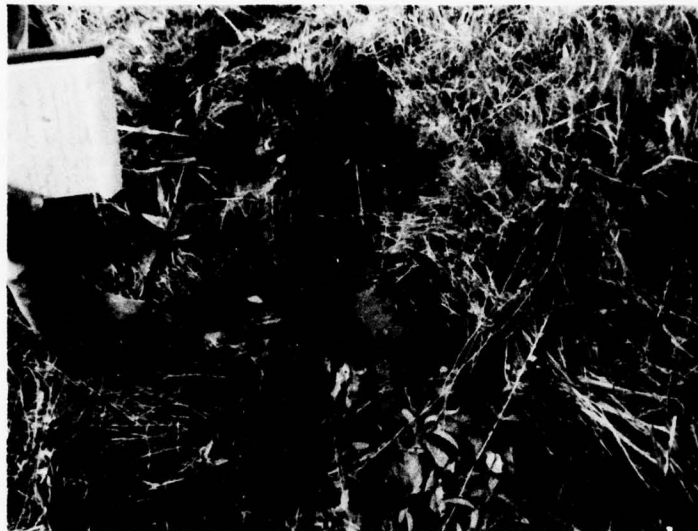
According to Mr. Birrell, Section Engineer, the seepage and saturated ground at the north abutment of Dam No. 1 has existed for a number of years except during extended periods of dry weather. Fine-grained soil is not in evidence either in the seepage or as accumulated deposits on the dam and valley slopes. The "Report to the Aqueduct Commissioners, 1895-1907" states, sic "notwithstanding that precaution (extending the corewall into what was considered competent bedrock), a slight infiltration occurs, which has been collected in a system of drains and led finally through small pipes, where its volume can be constantly observed." The location of these pipes is unknown and it is possible that the observed seepage is a result of a clogged drain system.

SATURATED GROUND NEAR RIGHT ABUTMENT  
OF DAM NO. 1

Seepage noted at the north abutment  
of Dam No. 1. Ground surface was  
moist and saturated in some  
locations.

A study should be undertaken to  
determine the cause and source  
of seepage and it should be  
monitored continuously to  
detect turbidity or increased  
flow.
